# Countermeasure Effectiveness Study at Signalized Intersection

The intersection of Highway 97 and 22nd Ave is a four-legged signalized intersection, located in a commercial/institutional area in Prince George, BC. An average of 21 road users per year had been involved in collisions at the intersection from 2014 to 2018, with one case resulting in a pedestrian fatality in June 2018. The City of Prince George planned to implement various countermeasures expected to improve safety at the site. Transoft Solutions processed the before and after video using BriskLUMINA, an automated analysis tool that uses artificial intelligence and machine learning to capture near-misses and other safety indicators. True North Safety Group (TNS) performed a before/after analysis using the BriskLUMINA outputs to determine the effectiveness of the countermeasures.

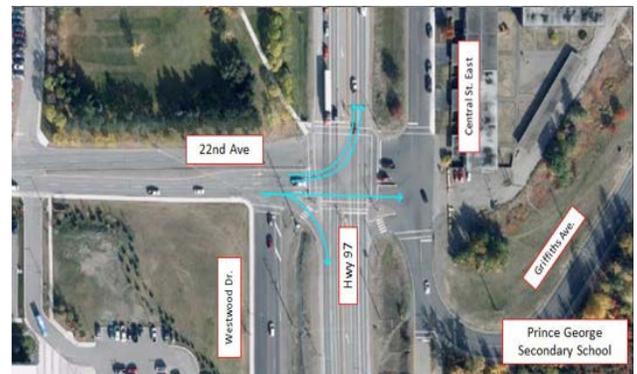
The Eastbound approach on 22nd Avenue has lanes, and one shared lane for right turns and through movements. The signalization for the two left turn lanes changed from permissive to protected from before to after. Each side of the intersection is equipped with a marked pedestrian crossing area (Figure 1). The crossing time for pedestrians was increased from 15 to 20 seconds on 22nd Ave, and from 17 to 22 seconds on Hwy 97 from before to after. Pedestrian countdown timers were also added at the pedestrian crosswalks.

Figure 1. Aerial view of the intersection of Hwy 97 and 22nd Ave in Prince George, BC

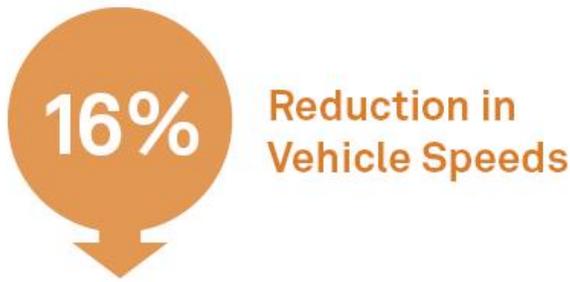
Figure 2. A 16% reduction in through vehicle speeds was observed Before vs. After implemented countermeasures

A 7% reduction in entering vehicle volume, and a 16% reduction in through vehicle speeds was observed from before to after. The capacity and speed reductions are most likely caused by the longer signal cycle lengths implemented to accommodate the protected-only-left-turn phase.

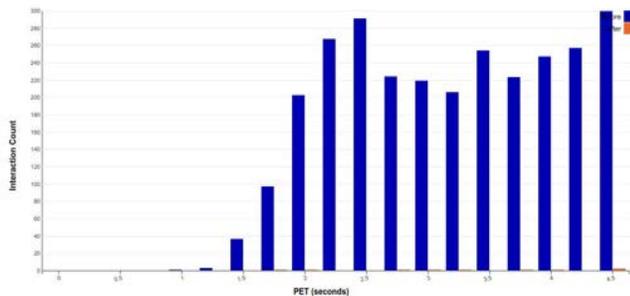
As can be seen from the PET distribution below, the frequency of conflicts between westbound through and eastbound left-turning vehicles dropped from an average of 15 critical conflicts (events with PET less than 3 seconds) per hour to virtually zero (Figure 3). Therefore, the implementation of the protected left-turn phase was determined to be successful in improving safety between westbound through and eastbound left-turn conflicts.

Figure 3. Conflict frequency distribution by PET Before vs. After implemented countermeasures

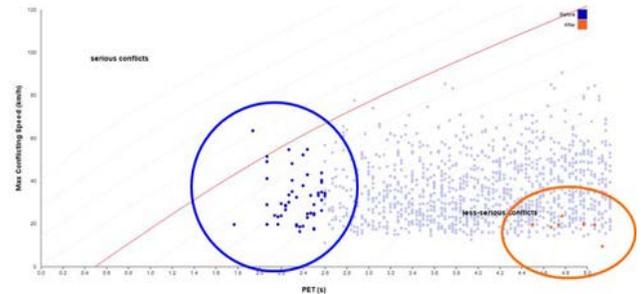
Each point in figure 4 represents a conflict observed during the video analysis. The points are plotted using the Swedish Traffic Conflicts Technique (TCT), developed by researchers at Lund University in 1972. This chart plots interactions measured by PET before vs. after the change was made. We can see that despite recording video during similar times of day, and similar volumes, there was a drastic change in the number of high-risk interactions.

There were 145 critical conflicts between eastbound left-turning vehicles and pedestrians crossing at the north crosswalk in the before period, while there were no critical conflicts for this scenario in the after period. This indicates that the countermeasures implemented were successful in reducing the conflict frequency between eastbound left-turning vehicles and pedestrians at the north crosswalk.

Figure 4. Conflict scatterplot for eastbound left-turning vehicles & pedestrians at the north crosswalk Before vs. After implemented countermeasures

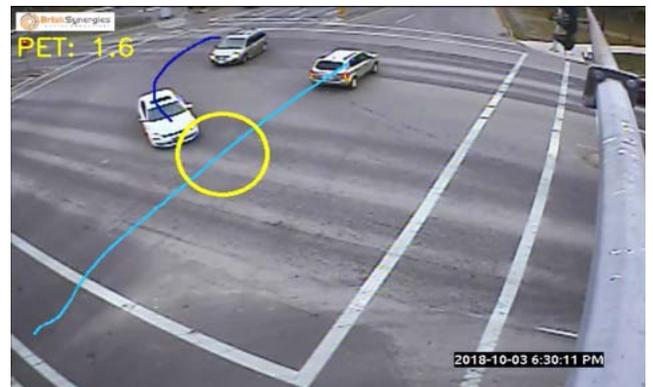
The implementation of the protected left phase addressed a major safety issue that can be illustrated in this before video (Figure 5).

Figure 5. Conflict Video Still

In the before scenario, a left turning driver could pass another left turning vehicle in the adjacent lane that was waiting for a safe gap. As the visibility of the passing driver would be restricted by the adjacent vehicle, the collision risk with a through vehicle was substantial. This type of conflict was not observed in the after period.
